**INTERIM CORRECTIVE MEASURES IMPLEMENTATION REPORT  
ASBESTOS SURFACE IMPOUNDMENT  
SOLID WASTE MANAGEMENT UNIT  
OCCIDENTAL CHEMICAL CORPORATION  
WICHITA, KANSAS**

**WESTON SOLUTIONS, INC.**

16 April 2008

W.O. No. 12340.011.001

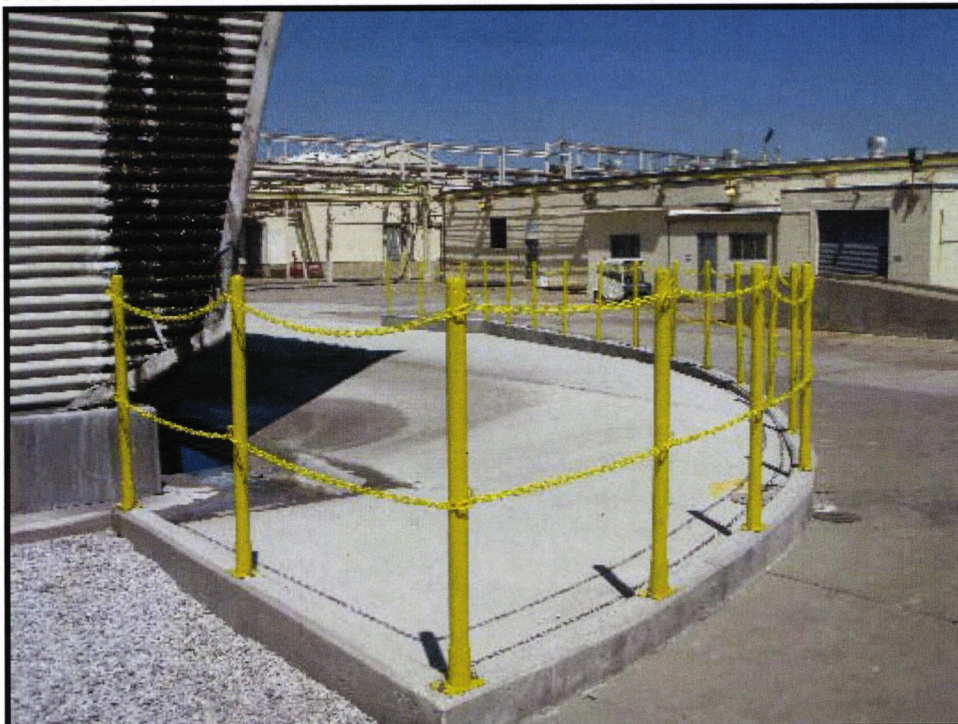
PHOTOGRAPH NO. 1

Concrete cap located adjacent to the east of cooling tower.

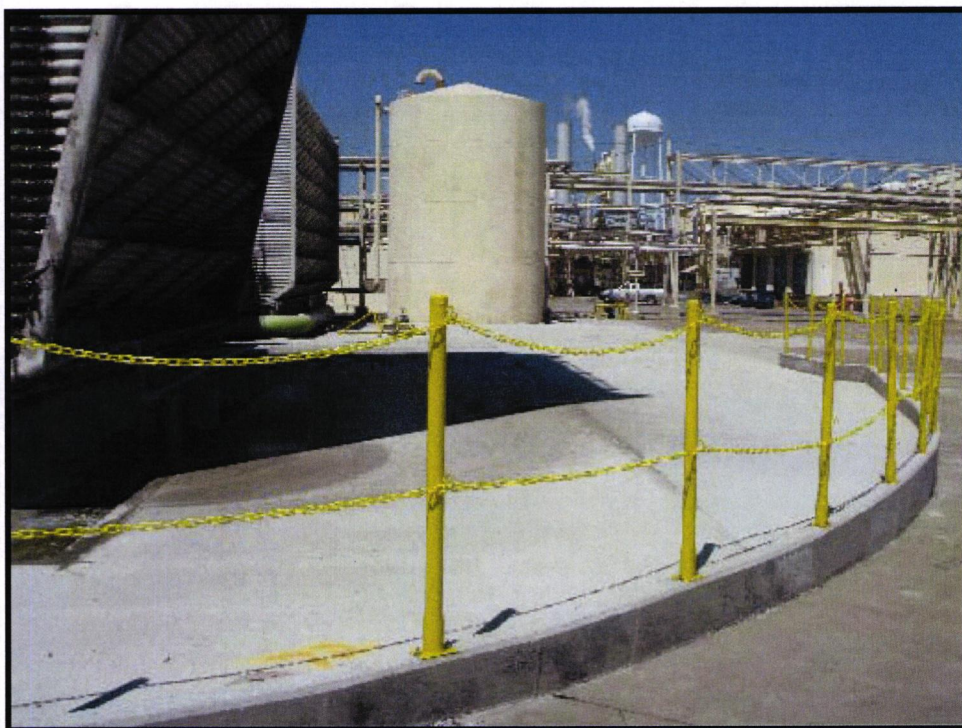
PHOTOGRAPH NO. 2

View of the concrete cap from the south.

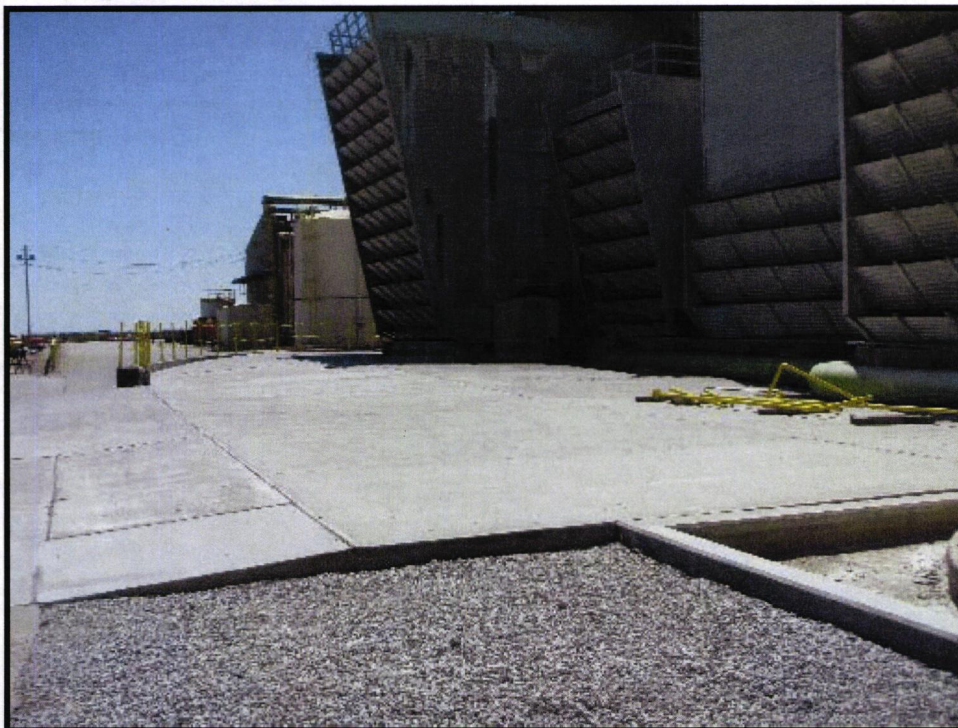
PHOTOGRAPH NO. 3

View of the concrete cap from the north.

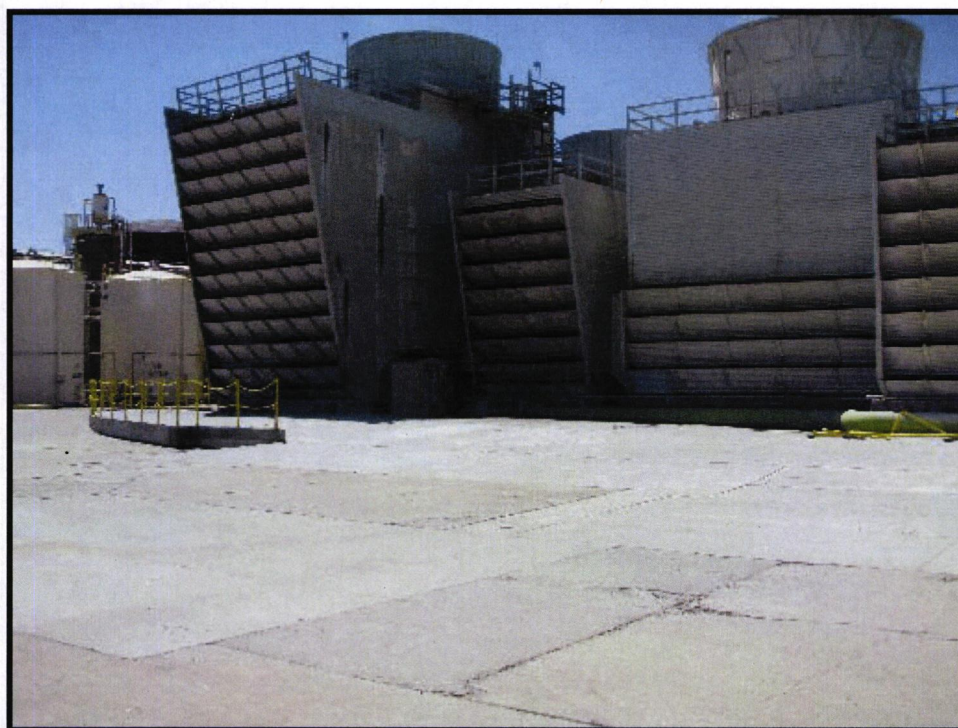
PHOTOGRAPH NO. 4

View of the concrete cap from the northeast.
